CONNECTICUT COASTAL BASIN
HAMDEN, CONNECTICUT

**FARM BROOK SITE 2A DAM
CT 01546**

**PHASE I INSPECTION REPORT
NATIONAL DAM INSPECTION PROGRAM**

SEPTEMBER 1981

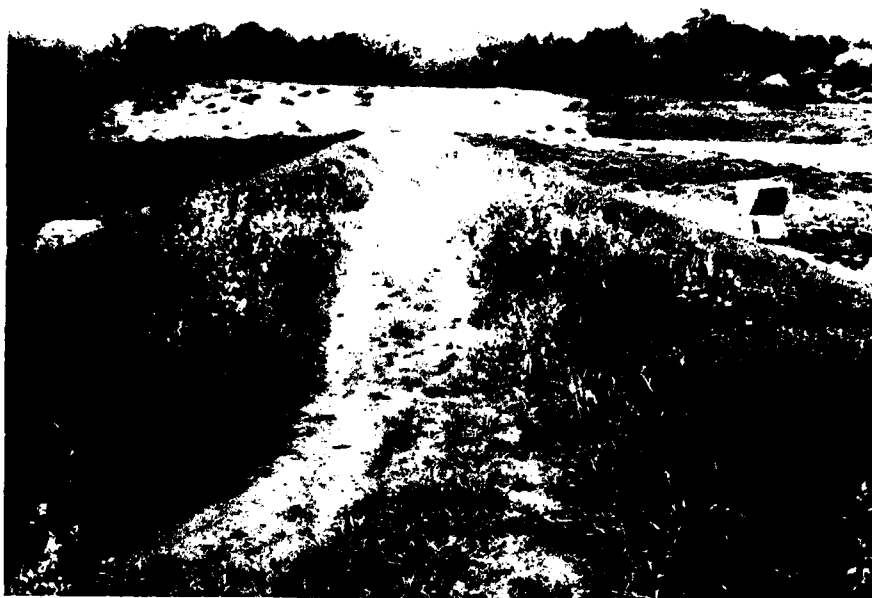
The dam consists of an earthfill embankment with a foundation drain trench underlying the downstream slope. As shown in Photos 1 & 2, the alignment appeared good with no sign of vertical or horizontal movement. Minor rutting was noted along the crest of the dam, resulting from vehicular traffic (see Photo 1). The exposed earth areas associated with the rutting were stable with no evidence of erosion. Trespassing was also observed along the upstream and downstream slopes (see Photo 3) of the dam embankment. Two wheeled vehicles, such as motorcycles have created bare earthen trails due to continuous usage. Although the vegetation has been removed, there was no sign of erosion at these areas. With the exception of

Photo 1 - View looking west along
crest of dam. Note
vehicular tracks with
exposed earth areas.

4. Restore vegetation on the bare earthen vehicular trails along the dam embankment and emergency spillway.
5. Repair concrete at fence post foundation on concrete impact basin.

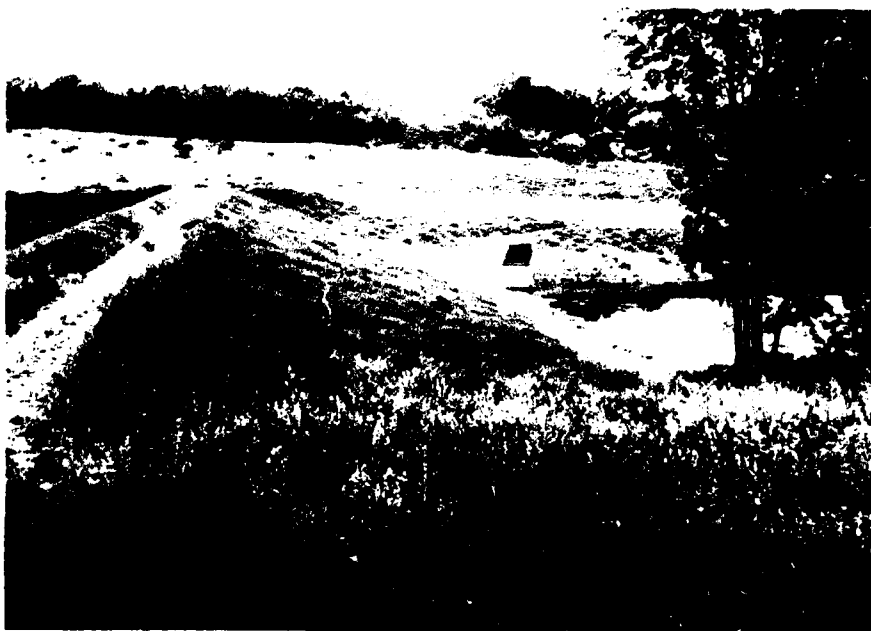
Photo 2 - Upstream slope of dam and
west side slope of
emergency spillway.

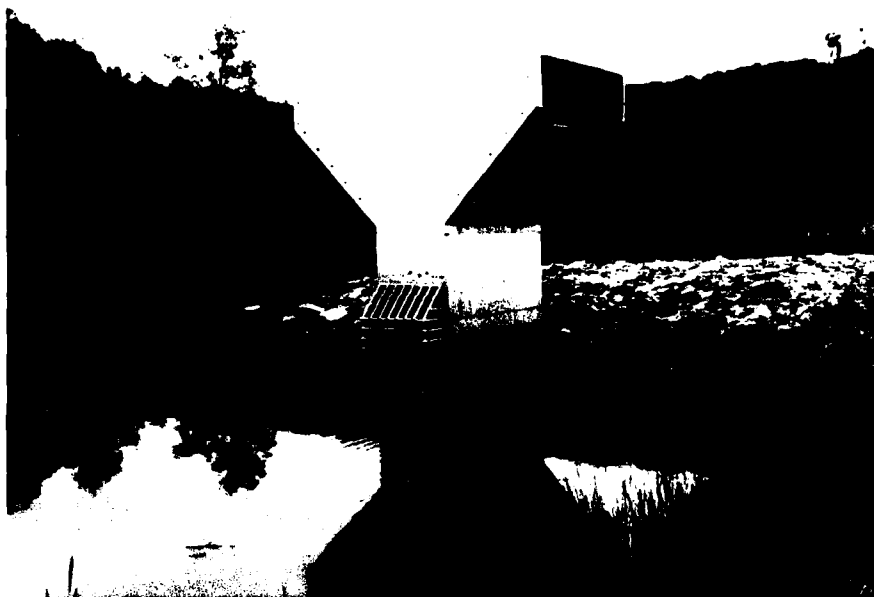
Impounded stormwater runoff and the normal flow to the reservoir passes under the dam embankment through the principal spillway. Consisting of a reinforced concrete intake riser, 30" pipe and impact basin, the principal spillway is generally in good condition. Numerous pock marks, possibly resulting from bullet impacts, were located on the north, south and east sides of the intake riser. Structurally sound and well painted, the steel trash racks at the high orifice and the crest riser were clean and free of debris as shown in Photo 5. Last operated in 1979, the slide gate at the low orifice was closed and fully submerged, preventing its inspection. Immediately south of the riser, the grouted riprapped area was in good condition with no indication of any cracking or failure.

Photo 5 - Two Stage reinforced concrete intake riser. Note grouted riprap area.

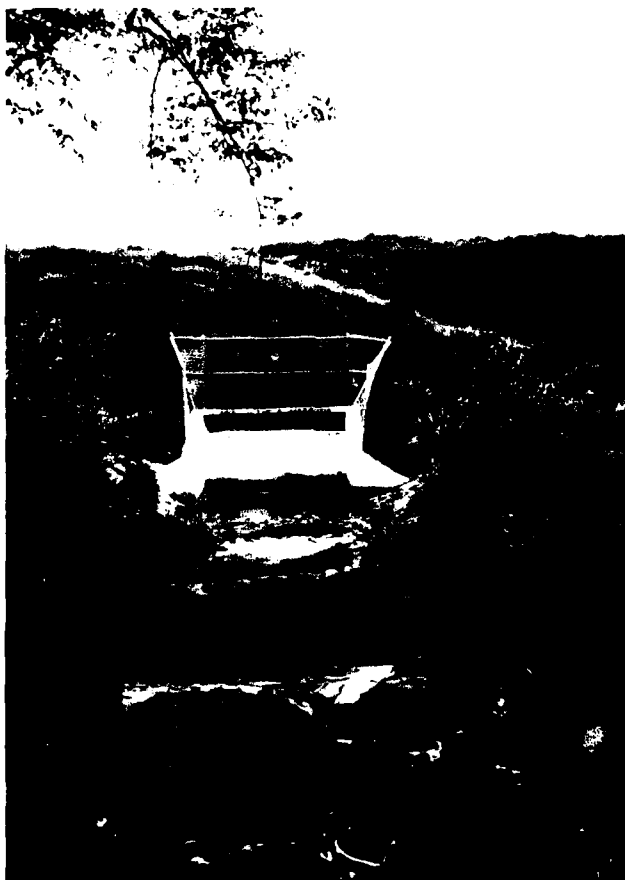
Situated on the downstream side of the dam is the reinforced concrete impact basin which is in good condition. As shown in Photos 6 and 7, the chain linked fence around the impact basin outlet, was tilted. The concrete at the base of the east and west center posts was cracked causing this problem. Directly downstream of the impact basin the riprapped areas, grouted and non-grouted, were stable and in good condition.

Photo 6 - Reinforced concrete impact basin. Note tilted fence.

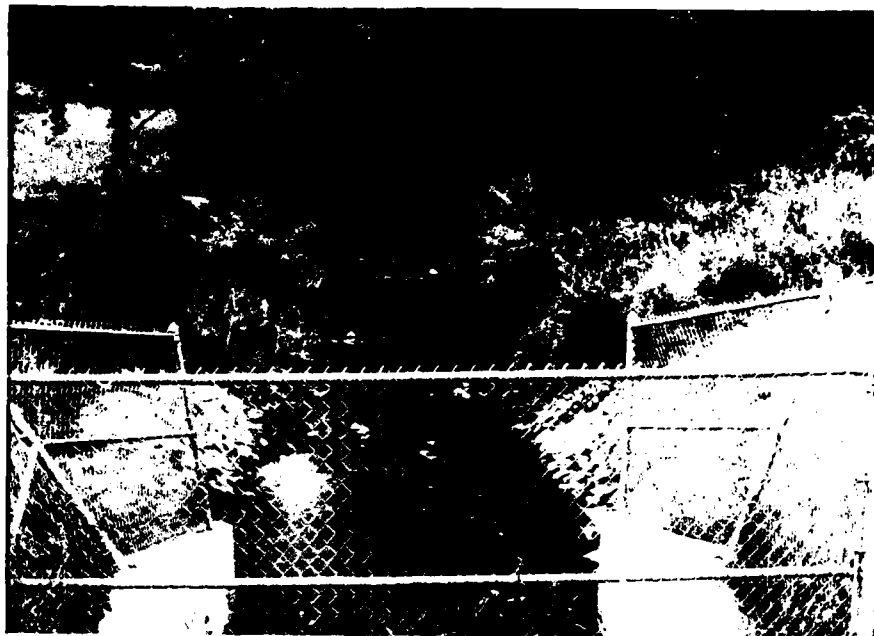
As shown in Photo 7, the channel downstream from the principal spillway is in good condition with no accumulation of debris. The riprapped areas immediately beyond the impact basin were stable with no evidence of failure. Minor brush growth and a few overhanging trees were noted along the channel farther downstream.

Photo 7 - Downstream Channel with
impact basin in foreground.
Note cracked concrete at
base of fence posts.
